RECONNAISSANCE REPORT OF DAMAGE TO HISTORIC MONUMENTS IN CAIRO, EGYPT FOLLOWING THE OCTOBER 12, 1992 DAHSHUR EARTHQUAKE

**Reconnaissance Report of Damage
to Historic Monuments in Cairo, Egypt
Following the October 12, 1992 Dahshur Earthquake**

Technical Report NCEER-93-0016

August 19, 1993

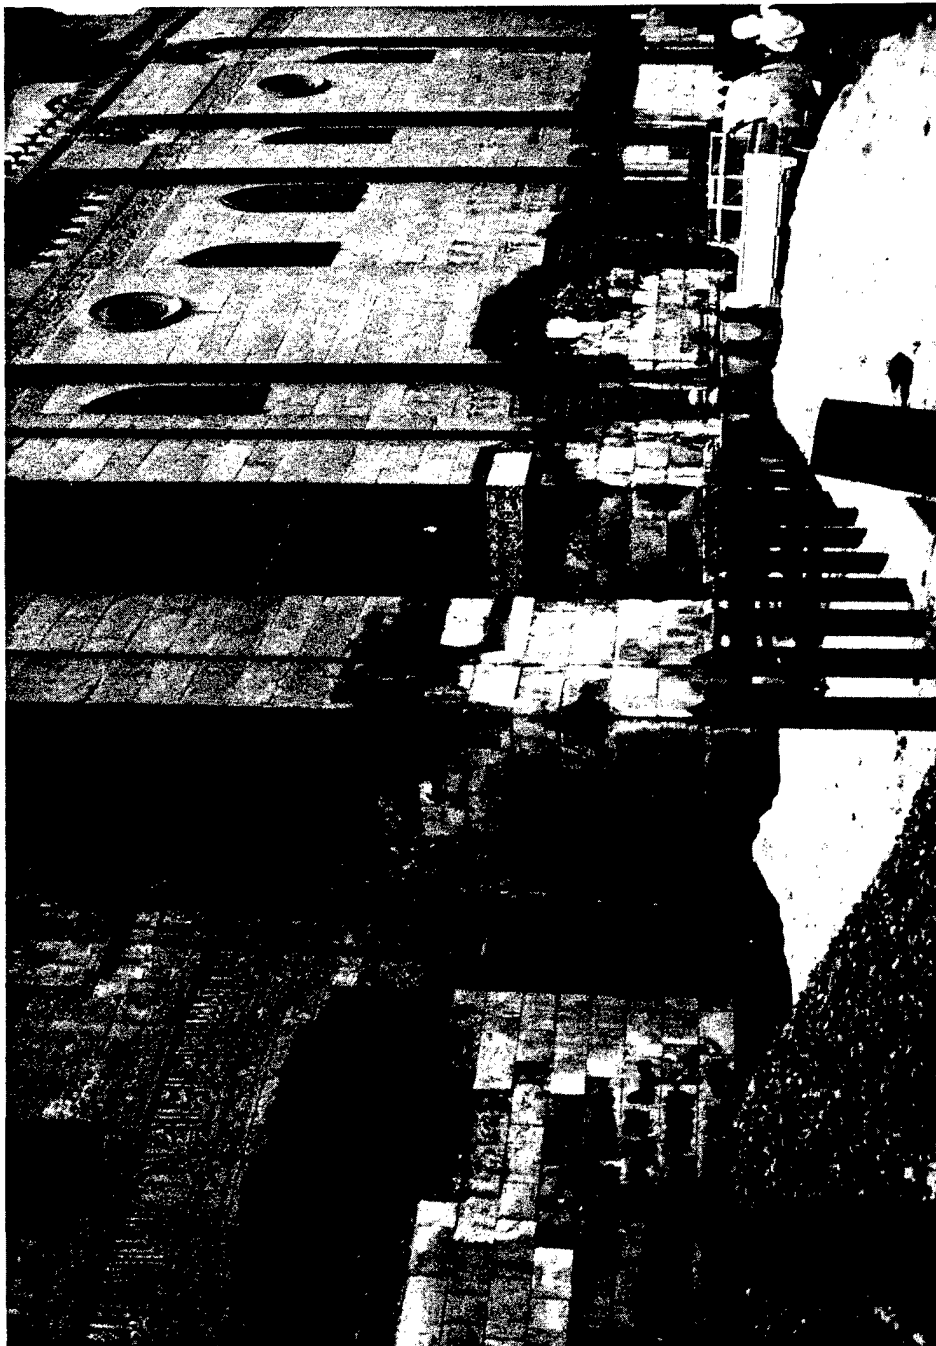
FIGURE 4-4 Southwest exterior wall of Mosque of Sultān Barqūq looking north showing dampness in masonry and progressive deterioration with height

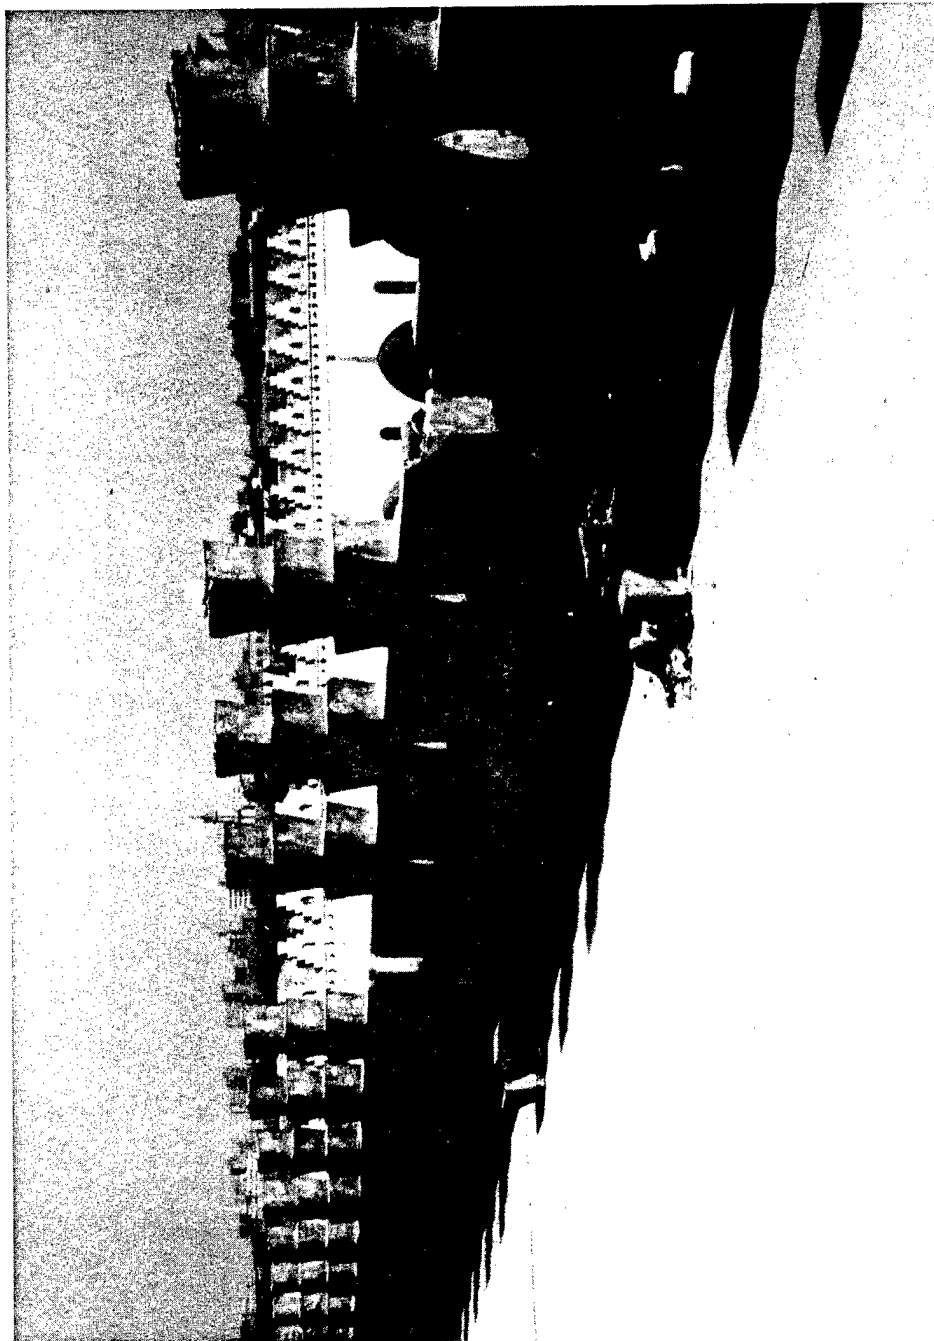
FIGURE 4-15 Walkway above arcade at al-Hākim Bi-Amrillāh Mosque
showing fallen parapets

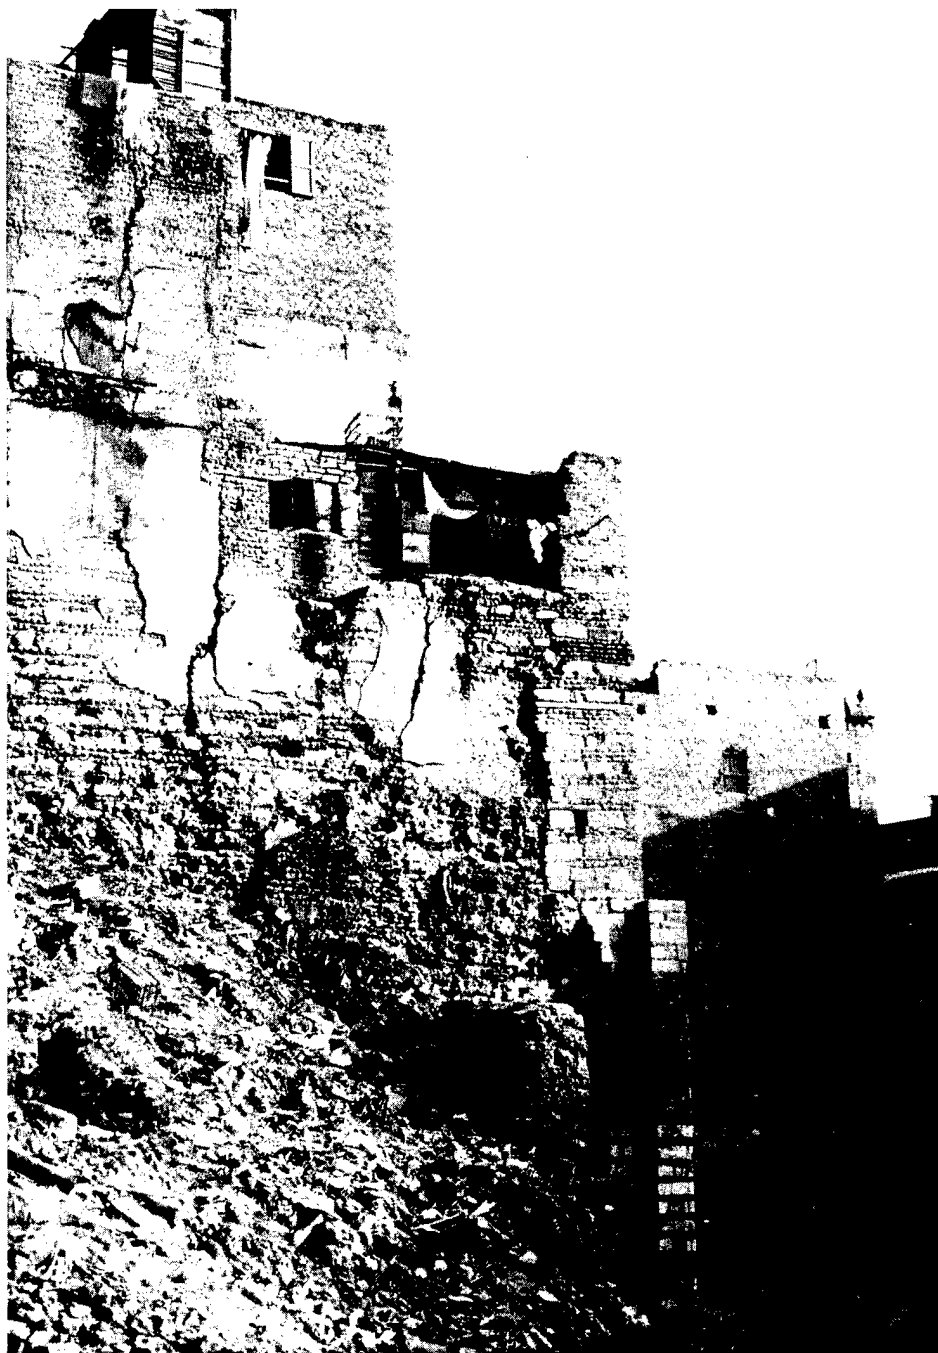
FIGURE 4-18 Residential housing unit behind remains of Madrasa of as-Sâlih Negm ad-Din Ayyub showing significant cracks

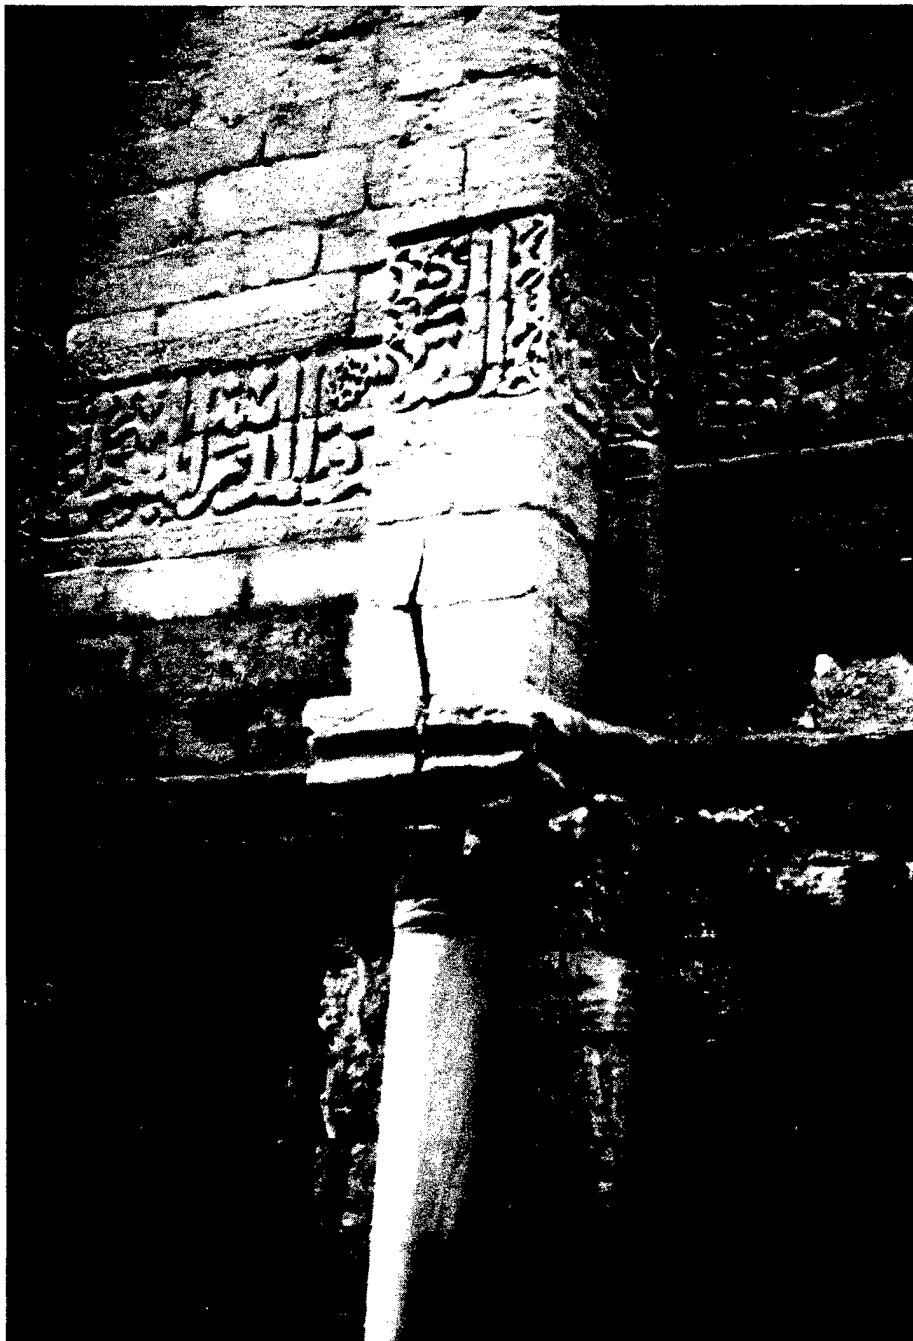
FIGURE 4-20 Marble column at base of recessed panel at Mausoleum of al-Mansur Qala'un showing large crack

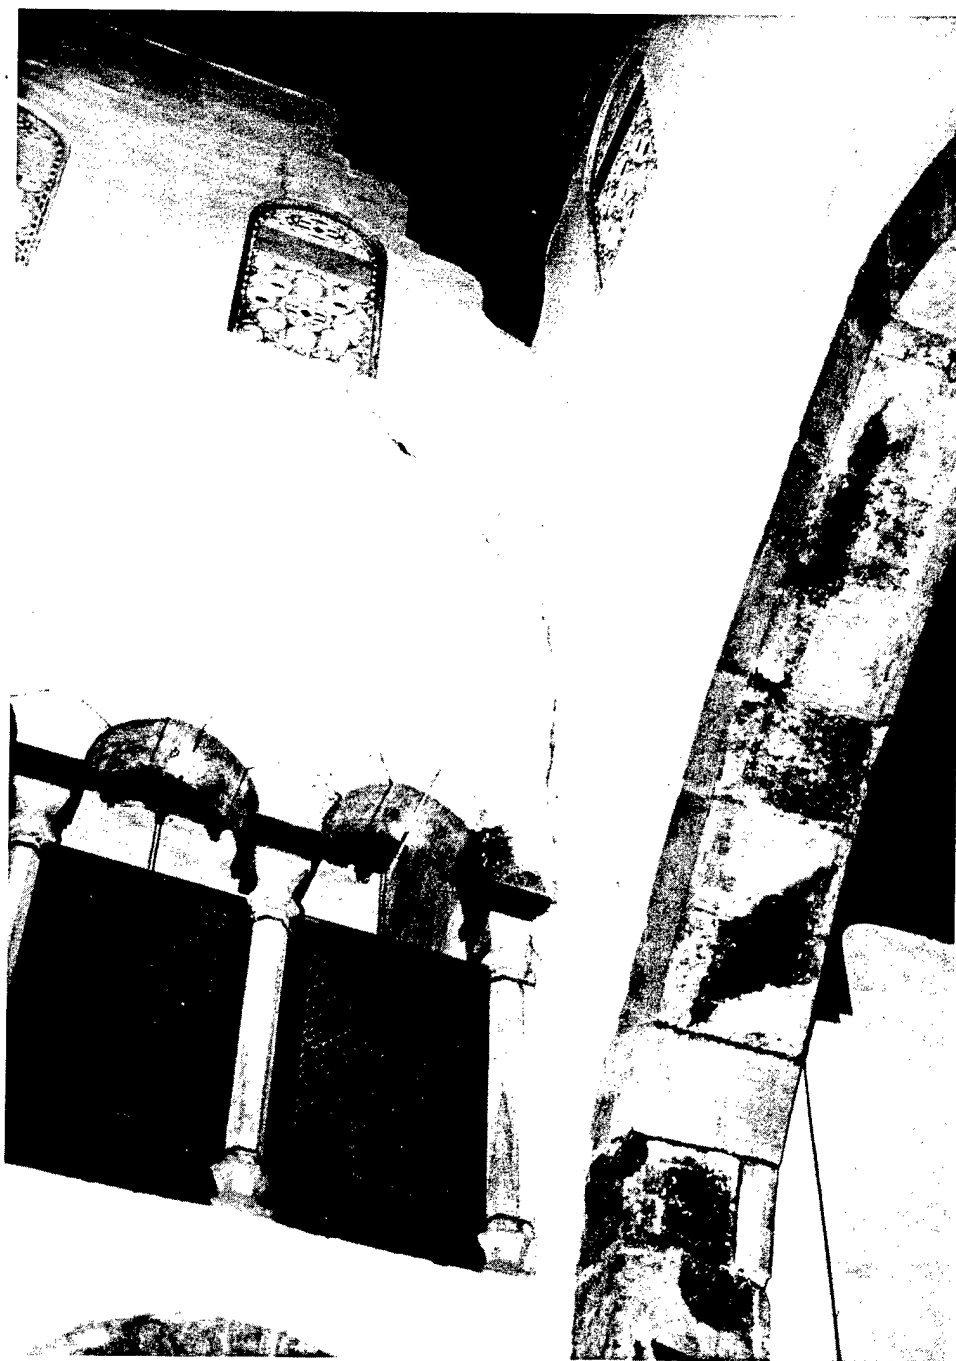
FIGURE 4-23 Western corner of qa'a at Palace of the Amir Beshtak showing large and continuous crack on southwest wall emanating from corner

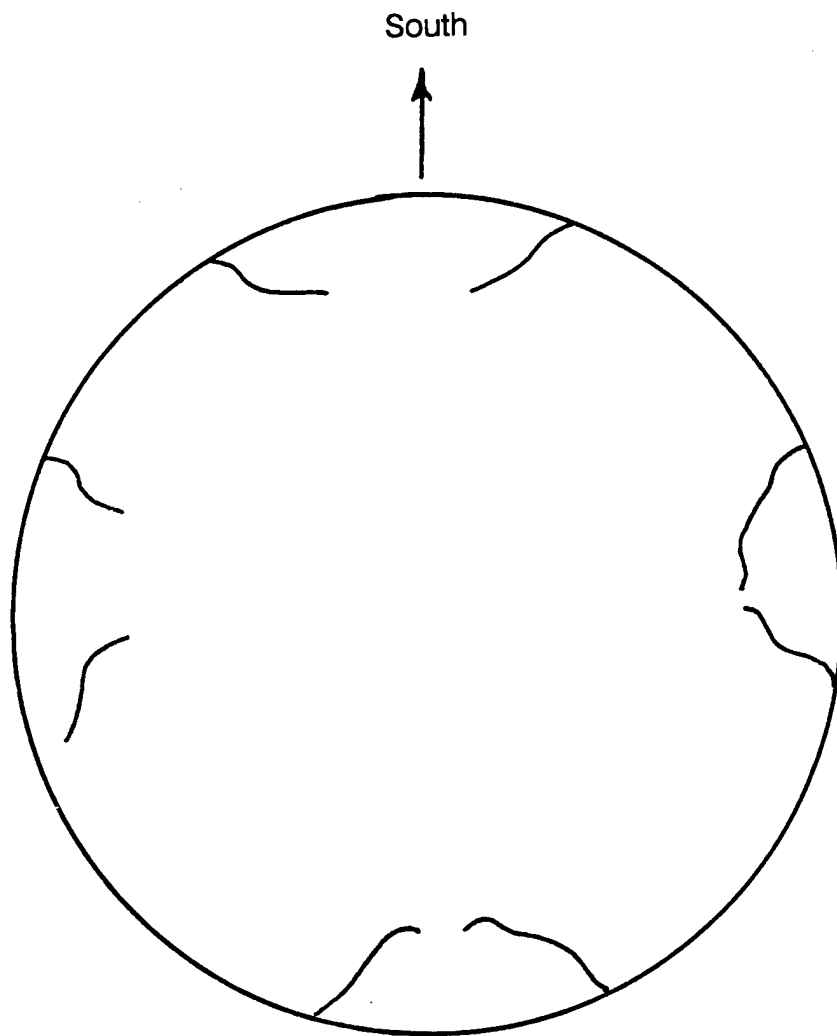
FIGURE 4-30 Sketch of interior crack pattern in dome of Mausoleum of Sultan Hasan looking up

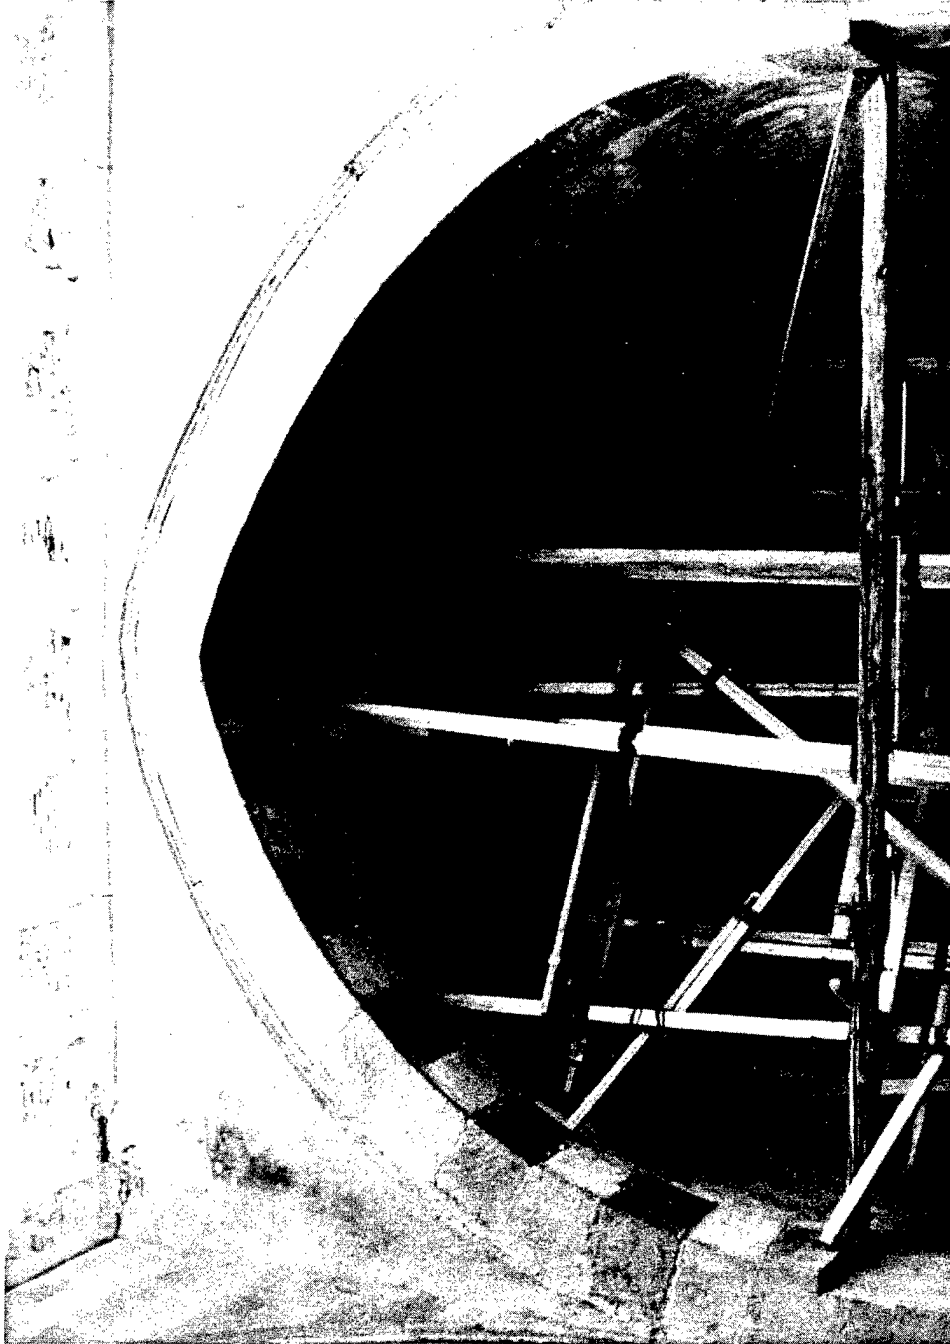
FIGURE 4-33 Arch at Mosque of Ibrāhim Āghā Mustahfizān showing cracks and bracing

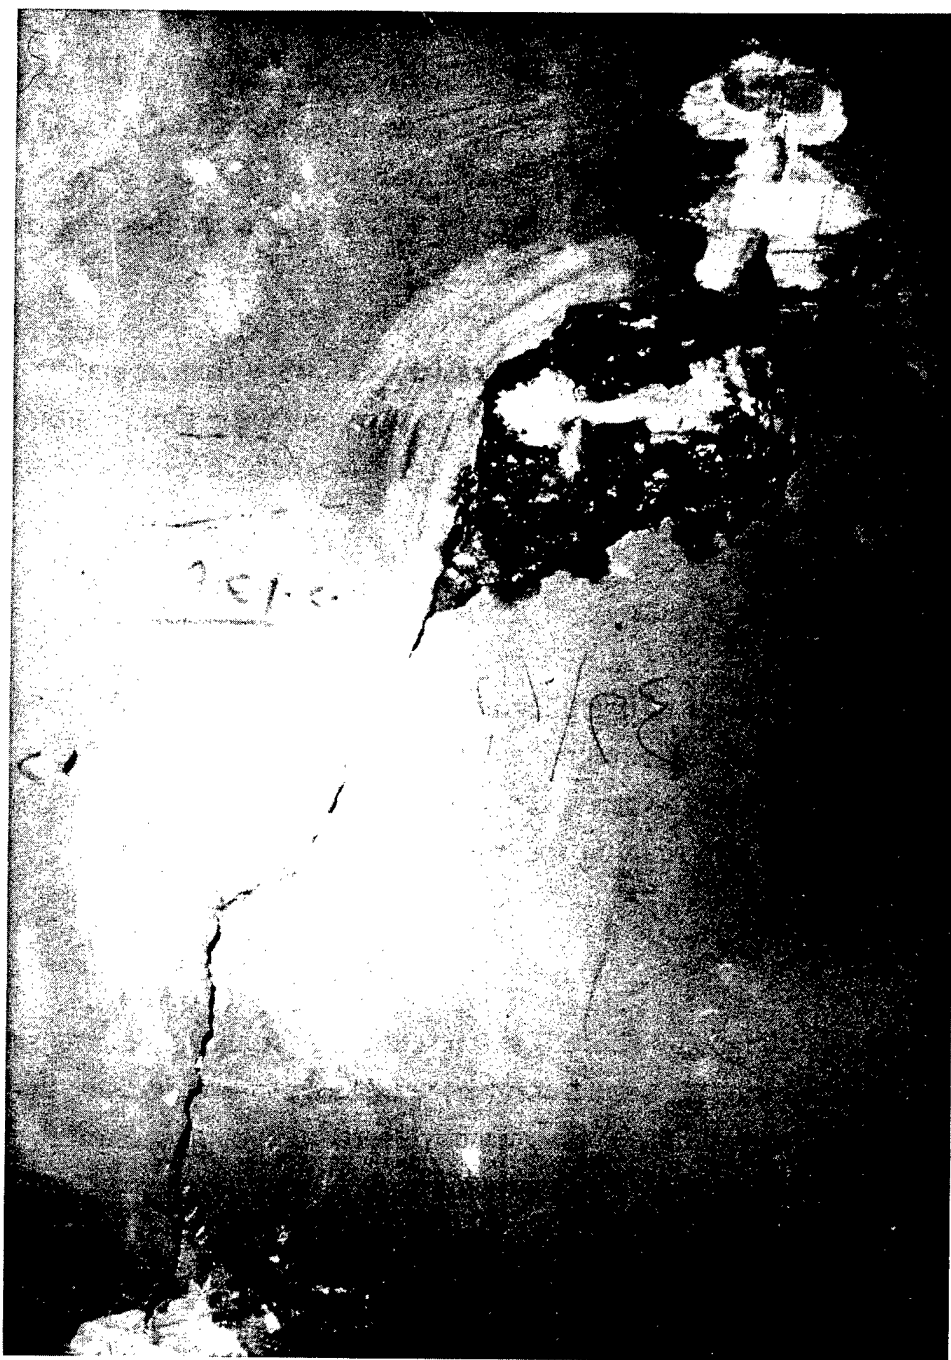
FIGURE 4-39 Interior wall of el-Moalloqa Church showing cracks and deformations

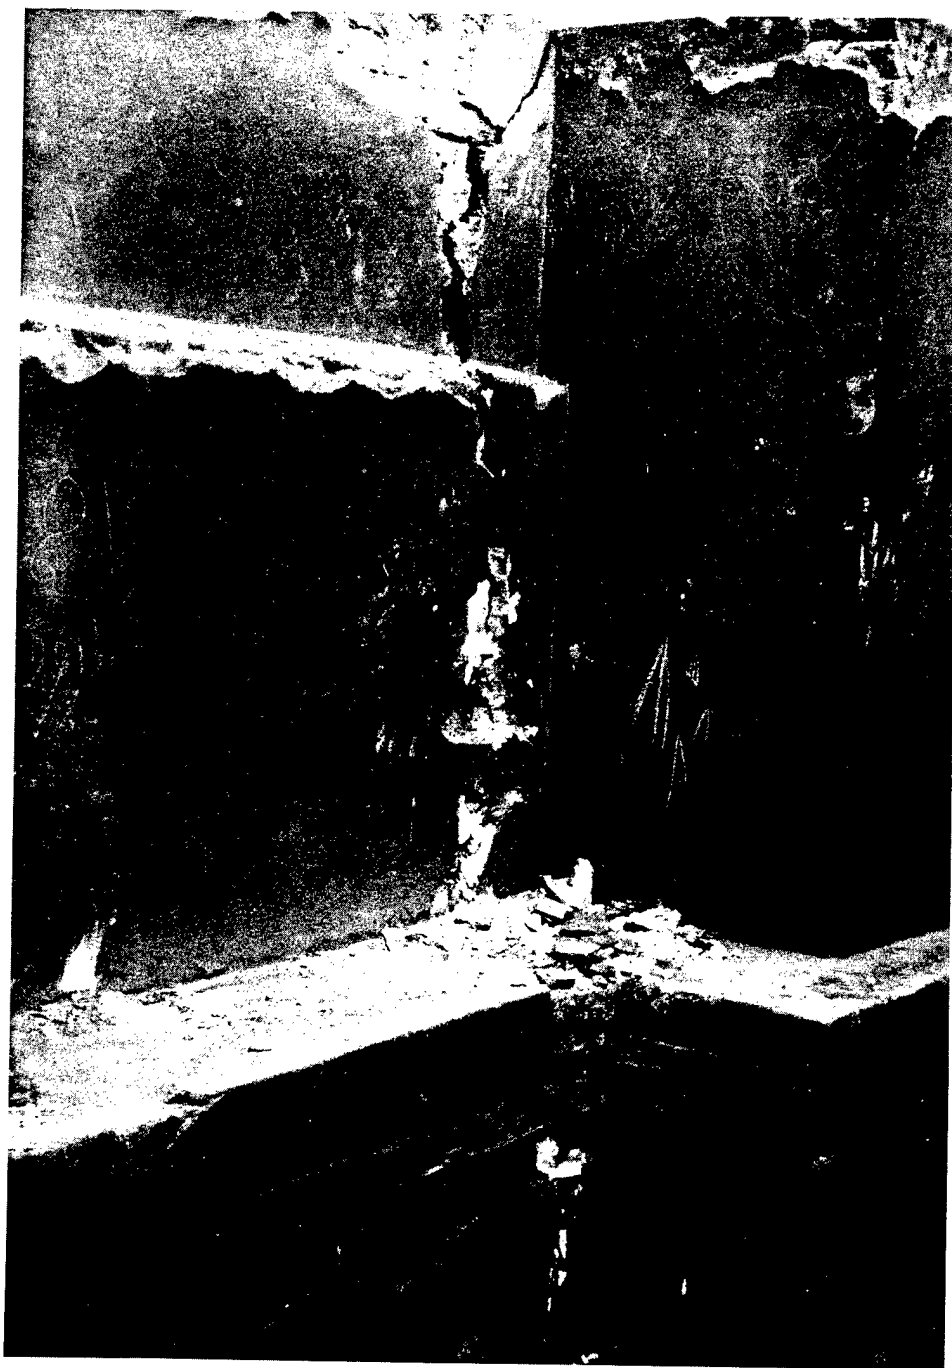
**FIGURE 4-41 Northern parapet wall of el-Moalloqa Church
looking east showing cracks and deformations**

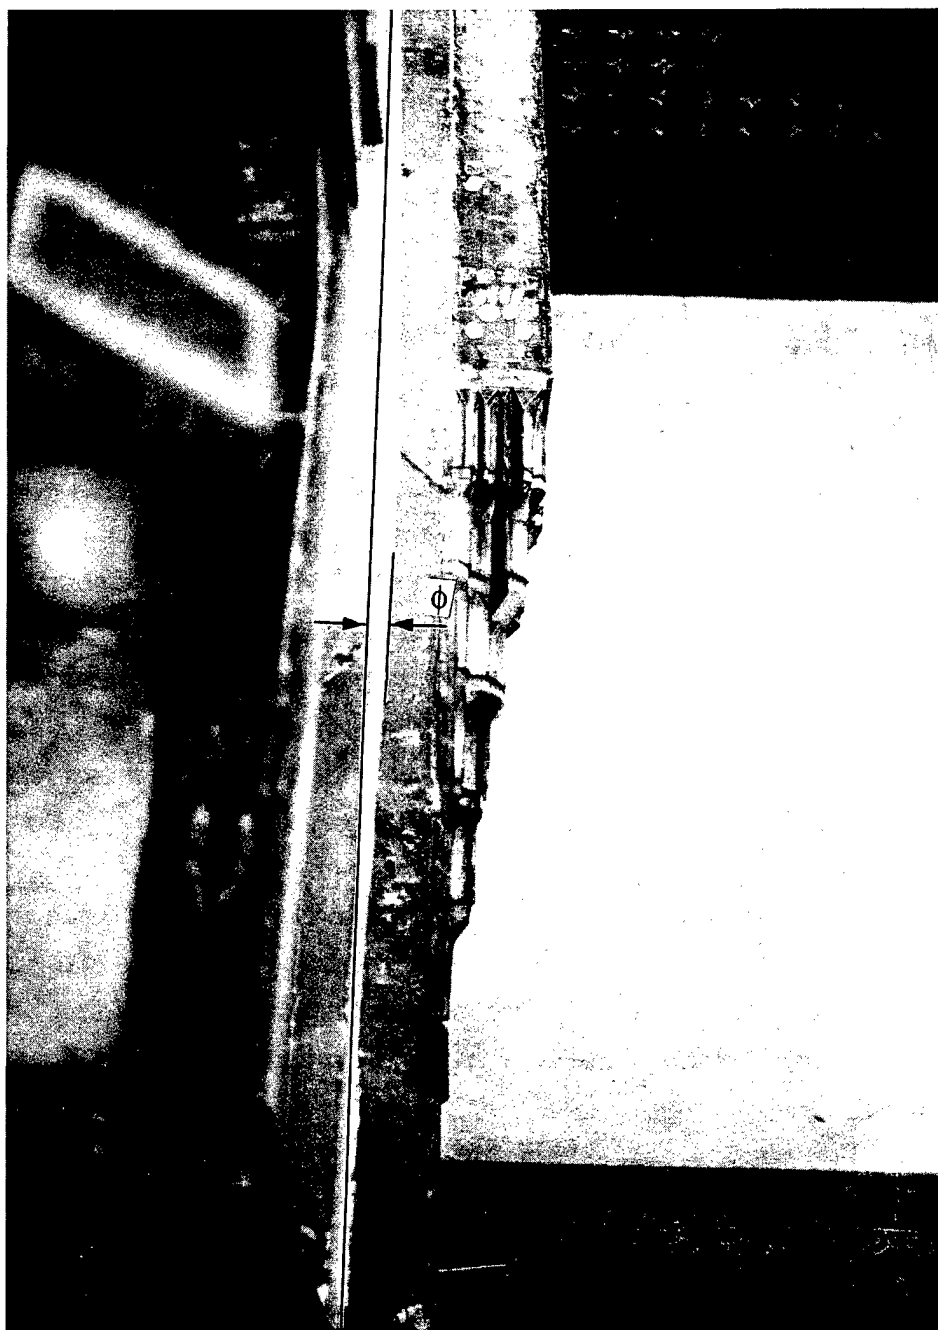
FIGURE 4-47 Interior wall and column at Bayt as-Sihaymi showing out-of-plumb column
